LESSONS LEARNED

MISHAP SUMMARY

7-ton (MK25) Rollover

Seven Ton (MK25) Rollover

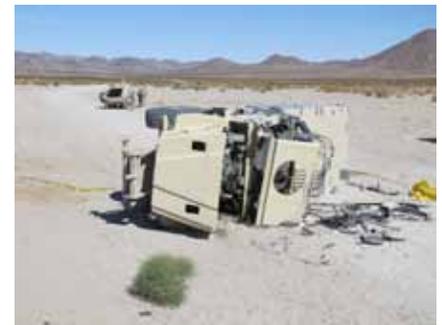
The Vehicle Commander failed to enforce the rules and regulations set by the Convoy Commander and in Base and Marine Corps Orders - he allowed the vehicle to operate at excessive speeds and did not ensure that seat-belts were worn. The lack of proper supervision by the Vehicle Commander led to the ejection of the Vehicle Commander from the vehicle and the partial ejection of the Driver which ultimately resulting in the fatal crushing of the Driver.

- The mishap driver had limited experience in flat-towing an up-armored HMMWV. The combination of excess speed and loss of situational awareness caused the mishap driver to over correct when he hit the berm on the left side of the road. The over correction allowed the up-armored HMMWV to pull the rear of the 7-ton into a fishtail and exacerbated the loss of control that led to the 7-ton rolling over.

- The mishap driver and assistant driver were not wearing seat-belts. As a result, they were ejected from the 7-ton and the mishap driver was fatally injured.
