mishap

LESSONS LEARNED

Mishap
AAV Sinking

Amphibious Assault Vehicle Mishap

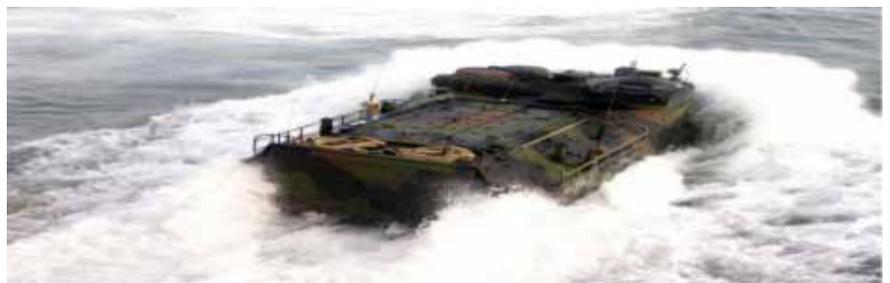
While conducting basic water operations, the accelerator pedal on an Amphibious Assault Vehicle got stuck in the depressed position. The vehicle's bow plane was not deployed. The driver made unsuccessful attempts at returning the pedal to a neutral/idle position and the vehicle's nose began to "plow in" to the water. Water rushed over the nose of the AAV and into the driver's hatch due to the excessive speed. The vehicle began to submerge and the driver and Marine in the troop commander's (TC) hatch were pinned to their seats from the force of the rushing water. The crew chief in the UGWS/turret dropped down in his hatch and informed the crewman in the troop compartment (mishap victim) to turn off the fuel shut-off lever and to prepare for evacuation of two other passengers. The crew chief exited the AAV as it submerged further.
