LESSONS LEARNED

MK-154 Wiring Harness Failure

Mechanical Mishap Causes Fatality

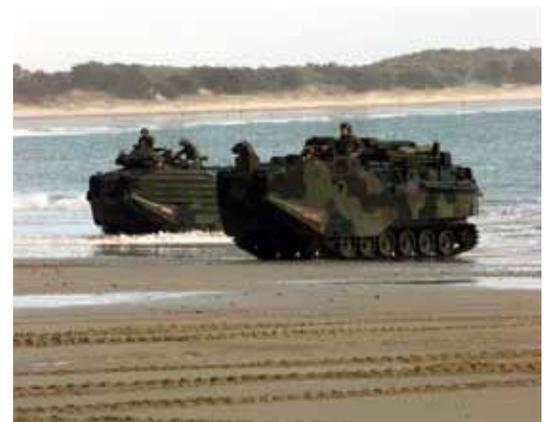
The mishap unit was conducting the Battalion Assault Course during the Integrated Training Exercise (ITX) aboard Marine Corps Air Ground Combat Center (MCAGCC), 29 Palms, CA. The conduct of this assault required an explosive breach to be conducted by a Mine Clearing Line Charge (MCLC) which the Battalion determined to deploy via the MK-154 MCLC system. The MK-154 is a special mission kit that augments the Amphibious Assault Vehicle (AAV) which allows for the amphibious deployment of the MCLC system. Per the scheme of maneuver, the mishap AAV and crew moved into position and requested permission to fire the MK-154 system. It was during the course of raising the MK-154 system into position that there was a premature firing of the rocket, causing one fatality and injuries to three other Marines.

- **Mechanical failure of the MCLC safety systems.** During the investigation it was discovered that over time a failure in the wiring harness can cause a loss of grounding which can lead to electrical current reaching the rocket leads prior to the rocket reaching its appropriate position and the launch button being depressed.
