mishap

LESSONS LEARNED

Artillery Training (Impact from Recoil)

Consequences from Artillery Mishandling

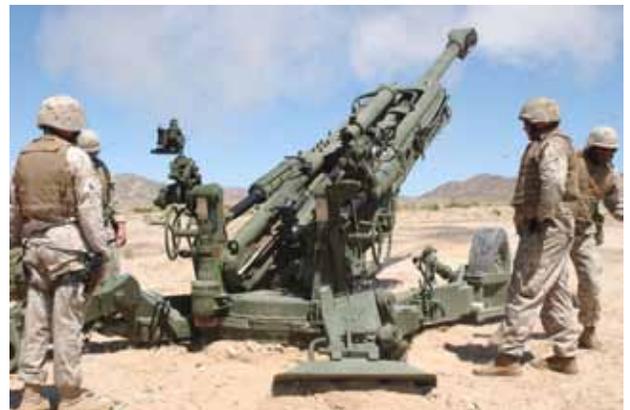
An Artillery Battery, conducting a live-fire exercise as part of a larger Battalion evolution, had a misfire occur on one of its howitzers. After the initial attempt to fire, an additional attempt to fire was made. Both attempts were made utilizing the firing linkage lever and six foot lanyard.

Prior to the third attempt to fire, the section chief instructed cannoneer #2 to attach the six foot lanyard directly to the M51 Firing Mechanism. During the third attempt, the M51 Firing Mechanism separated from the Primer Feed Mechanism Assembly (PFM). Cannoneer #2 was instructed to re-attach the M51 firing mechanism to the howitzer. As cannoneer #2 was re-attaching the M51 Firing Mechanism, the howitzer fired. During the recoil of the howitzer, cannoneer #2 was struck in the face by the breach and thrown against the M171A1 sight

- **Cannoneer #2 “hand firing” the howitzer.** It is believed that while cannoneer #2 inserted the firing mechanism into the PFM, he twisted the firing mechanism clockwise which resulted in the firing mechanism initiating the firing pin, causing the gun to fire.

- **Gun crew failed to conduct misfire procedures as per Marine Corps TM 10407C-OR/1 and JREGTO 3570.1d.** When cannoneer #1 attempted to fire, the howitzer did not fire. As per Marine Corps TM 10407C-OR/1, this is considered a misfire. Cannoneer #1 attempted to fire again with the same results. At this time the section chief should have made the decision to fire in the degraded mode, which consists of attaching the 25 foot lanyard directly to the lanyard lever (conducted by cannoneer #2) as opposed to utilizing the Remote Firing Linkage (RFL). In this situation, the section chief decided to continue utilizing the six foot lanyard. When the section chief pulled on the 6 foot lanyard

- **Improper breach maintenance.** The incorrect installation of the firing mechanism (rotated 180 degrees) was the cause of the initial misfire. The morning of the incident, the gun was conducting breach maintenance. The installation of the firing mechanism into the PFM is one of the primary duties of cannoneer #2. However, this did not happen. Cannoneer #2 was fixing aiming stakes while the recorder reassembled the breach. This resulted in the incorrect installation of the firing mechanism, which caused the initial misfire.

- The technical manuals do not specifically define “attempt to fire.”
- As a result of this mishap, a Safety of Use Message was released on 041523Z FEB 14 and directs that all units and personnel be instructed on the hazard and proper operation of the M777A2 howitzer as related to the M51 Firing Mechanism. Specifically, the M51 Firing Mechanism shall not be installed, removed, or reoriented on a loaded howitzer.
