**mishap**

MISHAP SUMMARY

Mishap
Billeting Area Fire

Billeting Area Fire

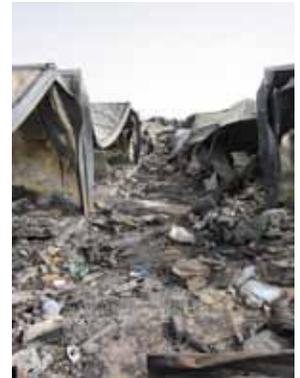
A unit operating from a forward operating base (FOB) in a remote location of Afghanistan was living in a locally fabricated billeting structure. The structure consisted of 20' shipping containers lined with plywood (tack welded together to form a 20' x 25' room) and eleven relocatable buildings (RLBs) that were subsequently covered with a corrugated steel roof. The overall structure had a north and south exit, but the individual RLBs only had one exit that led directly into a common hallway. The origin of the fire was a locally purchased step-down transformer (220v to 110v) that overheated and caught fire in a common room at the south end of the building. When the fire was discovered it was already too hot to contain and the structure was engulfed in flames and thick black smoke in a matter of minutes. Three Marines perished in the fire and two others received second and third degree burns during the rescue efforts.
