LESSONS LEARNED

MISHAP SUMMARY

System Management Unit Fire

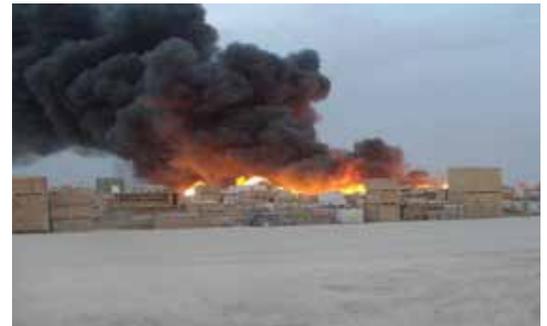
At approximately 1830, a fire was noticed at a System Management Unit (SMU) lot. A small group of Marines quickly responded, but they were unable to contain the fire and it spread throughout several nearby, stacks of tri-wall and wooden boxes. The aircraft rescue and fire fighting section (ARFF) self responded, also unable to contain the blaze. Additional fire fighting units from nearby camps and airfield fire fighting crews responded to assist. Marines driving heavy equipment bulldozers attempted to create fire lanes to slow and contain the fire. As dusk approached, a sandstorm struck creating confusion, shifting wind patterns and reducing visibility to approx. 1-3 ft, thus forcing the ARFF to abandon the SMU lot which subsequently led to two P-19 fire trucks being destroyed. The fire was contained seven hours later. Small fires and hotspots continued for several days.

The fire department conducted an investigation of the suspected origin area of the fire; however, it was impossible to conduct any type of forensic investigation to determine the exact point of origin or any type of potential evidence. The board concluded that the most likely cause of the fire was personnel smoking on the SMU lot outside of the designated smoking area.

- Material overcrowding on the lot; stacking of containers, less than adequate work space, no protection of supplies from the elements, narrow traffic lanes.
- Inadequate quantity of fire extinguishers staged throughout the lot.

- Inadequate perimeter security (unauthorized access by smokers).
- Lack of access and egress points for emergency vehicles.
- Poor communications for emergency response (land line failure, shortage of radios, excessive radio chatter).
- Lack of sufficient water resources to effectively resupply fire fighting vehicles.
- Adverse weather conditions (high winds and low visibility) throughout the fire significantly affected the severity of the fire and the firefighter's ability to gain control.
- Inadequate intermediate supply procedures and documents to provide guidance for open lot storage in an expeditionary environment.

- SMU lots must be of sufficient size to support current and future operations, to include adequate protection of material from the elements and access for emergency vehicles throughout the storage lot.
- Fire extinguishers of appropriate size and type must be staged throughout the storage lot, not just limited to office spaces.
- Ensure additional access and egress points for emergency vehicles are established throughout the perimeter of SMU storage lots.
- Ensure effective means of communication are established with all emergency service organizations located aboard individual camp complexes.
- Ensure units have a plan to provide for best possible resupply of water to firefighting vehicles.
