USMC SAFETY & FORCE PRESERVATION

NOV 2011

TACTICAL VEHICLE MISHAPS

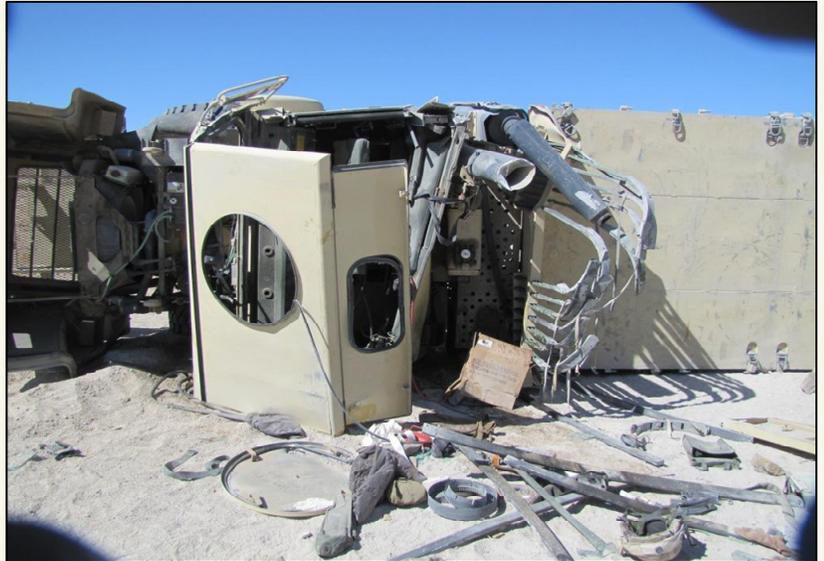
FY 2011 was our best year on record for tactical vehicle safety – a 60% decrease compared to the 10-year average. In July we had a M970 Refueler rollover and in October we had two back-to-back tactical vehicle mishaps where we lost or seriously injured Marines due to rollovers: Medium Tactical Vehicle Replacement (MTVR), and an Amphibious Assault Vehicle (AAV).

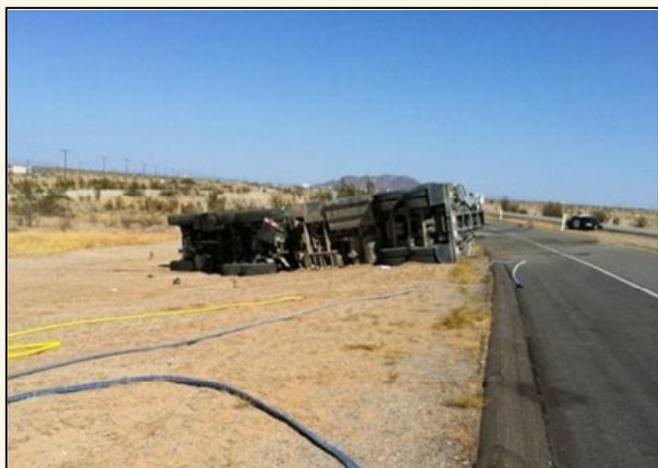
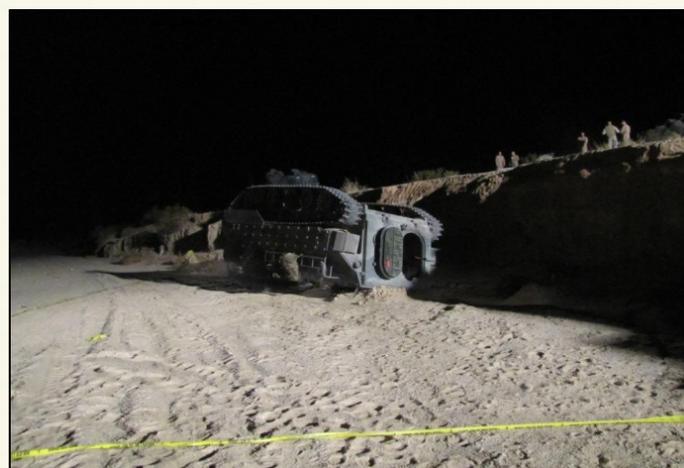
* Actual Images of Recent Marine Corps Tactical Vehicle Mishaps

- Properly tying down and storing gear prevented further injuries.
- Marines are always subjected to the inherent risks associated with our profession even though we have taken all the appropriate steps, as seen in the AAV rollover risk mitigation (ORM, multiple safety and convoy briefs).
- Complacency kills – Not wearing seatbelts, speeding, failing to understand the vehicles center of gravity, and overcorrecting.
- The key component in mishap reduction is that of involved leadership, training, situational awareness coupled with improved survivability and restraints, wider use of risk management and strict adherence to proven TTPs.
